**WELL DECOMMISSIONING
ON THE LUMMI INDIAN RESERVATION
DURING 2006**

Prepared for:

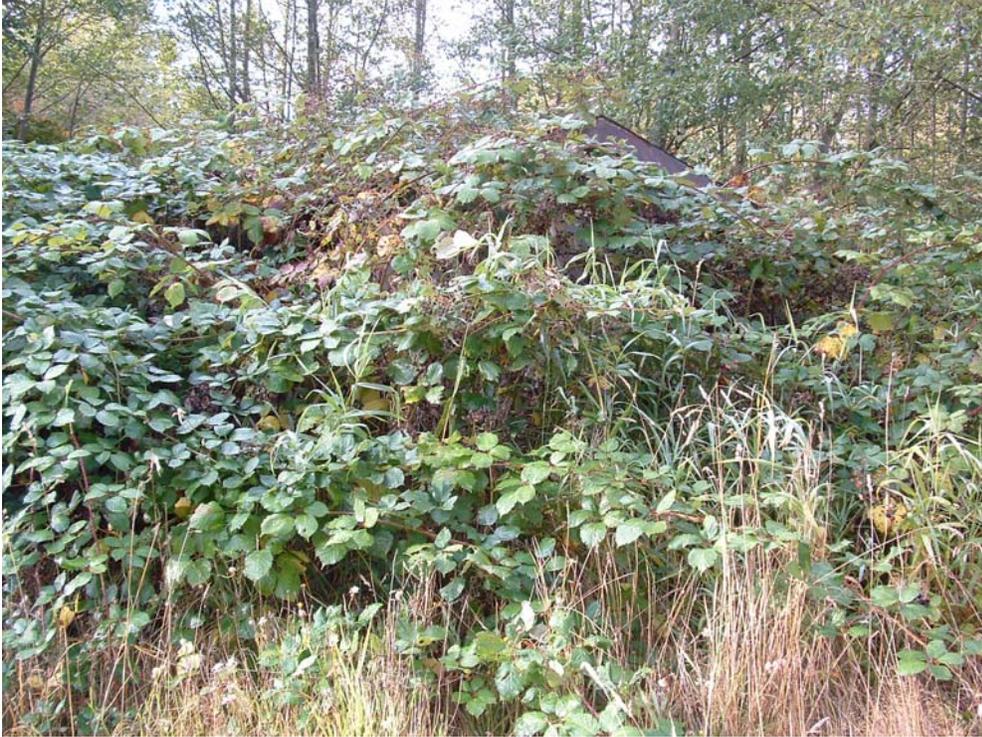
No problems with the well were encountered during decommissioning. The pump and associated piping were removed and salty-looking deposits were observed in the pump pipe immediately above the submersible pump. The casing was perforated from 6' (about 5' below ground surface) to the top of the screen, after which the well was filled from the bottom to the top with bentonite slurry. Several days later, the casing was cut-off 3 feet below the ground surface and the area immediately over the well covered with topsoil.

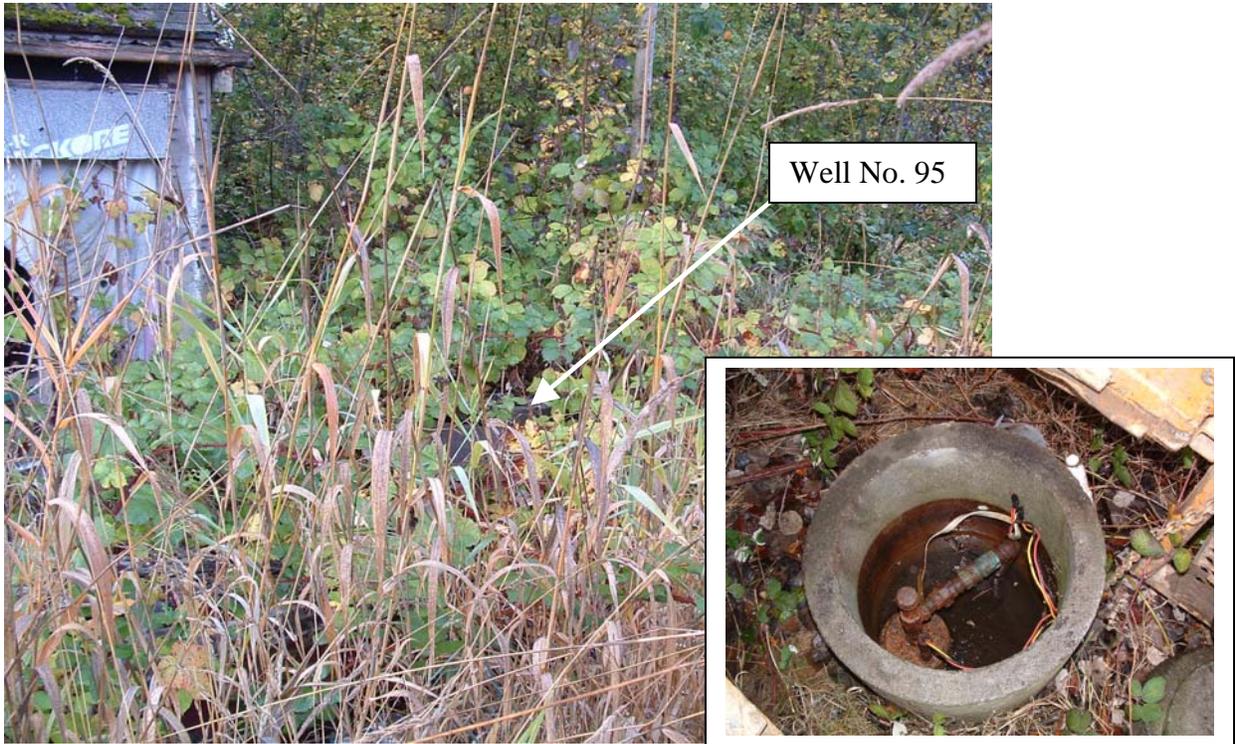
The entire length of the casing was not fully perforated due to problems encountered during the decommissioning. The apparent cause was the casing breaking at a welded joint. The bottom 14 feet of the well (from 40 to 54 feet) was partially perforated. The remainder of the well casing from 14 feet above the screen to the land surface (40 feet) was fully perforated. The determination was made that the lack of complete perforation near the bottom of the well would not comprise protection of aquifer. Bentonite slurry was placed from the bottom to the top of the well. Many days later, the casing was cut-off 2.5 feet below the ground surface and the area immediately over the well filled with topsoil.
