**date:** October 20, 2009  
**to:** Jeremy Freimund, Lummi Nation Water Resources Manager  
**fr:** Jim Johannessen LEG, MS, and Jonathan Waggoner, CGS  
**re:** **Lummi Reservation – Final West Beach Summer 2009 Beach Monitoring**

# WEST BEACH LUMMI PENINSULA Beach Topography, July. 2009

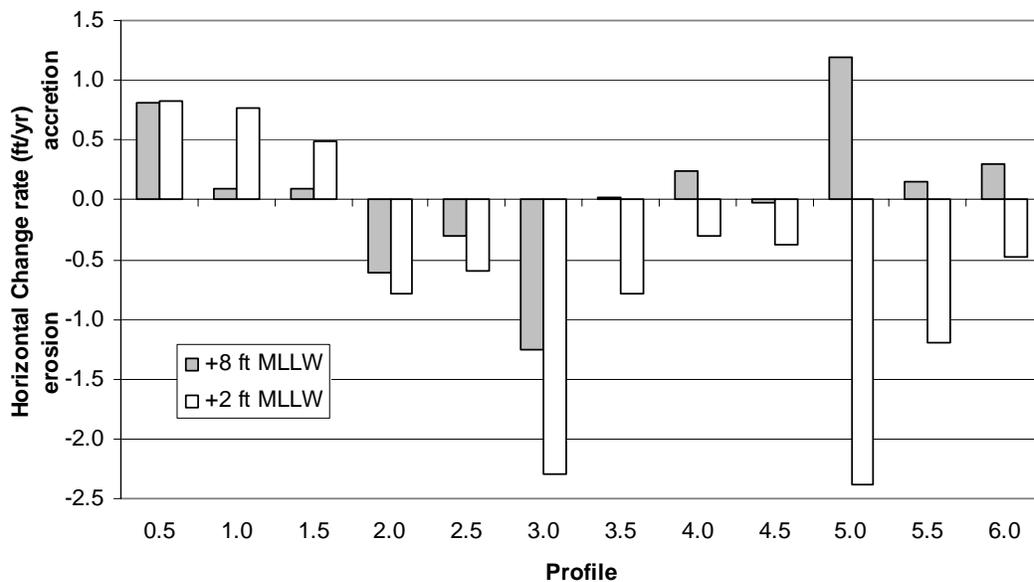
**Figure 1.** Horizontal change rates for +8 and +2 ft MLLW between 2003 and 2009 (except as noted).

The upper beachface shore change was measured at +8 ft MLLW, just below the location of MHHW. Since 2003, neither erosion nor accretion was the consistent pattern at the upper beach. Erosion was the clear upper beach trend at Profiles 2.0 to 3.0 (0.3 ft/yr to 1.3 ft/yr), and mostly minor accretion at the ends of the study area over the last six years. Change rates at the +8 ft MLLW elevation are more indicative of the entire high tide beach profile than changes at +2 ft MLLW. The lower beachface, measured at +2 ft MLLW (or +4 at Profiles 1.0, 2.5, 5.5, and 6.0) elevation, had accreted at Profiles 0.5 through 1.5, while erosion predominated from Profile 2.0 north to Profile 6.0. The highest erosion rate was at Profile 3.0 at -2.3 ft/yr. This can be compared to the measured bluff toe change rate at Profile 4.0 of -0.33 ft/yr since 2003 and "typical" coastal erosion rates in North Puget Lowland of -0.2 to -0.4 ft/yr (Keuler 1988).

Lower beachface horizontal change rates tend to agree with the above assessment. Profiles 0.5 through 1.5 had accreted between 2003 and 2009 while Profiles 2.0 through 6.0 had eroded (Table 2, Figure 1). Upper beachface change appeared to show a similar trend, although inputs of bluff sediment due to toe erosion and landslides appear to have been substantial enough during recent years to offset some of the upper beach coastal erosion that may have occurred without this sediment input.

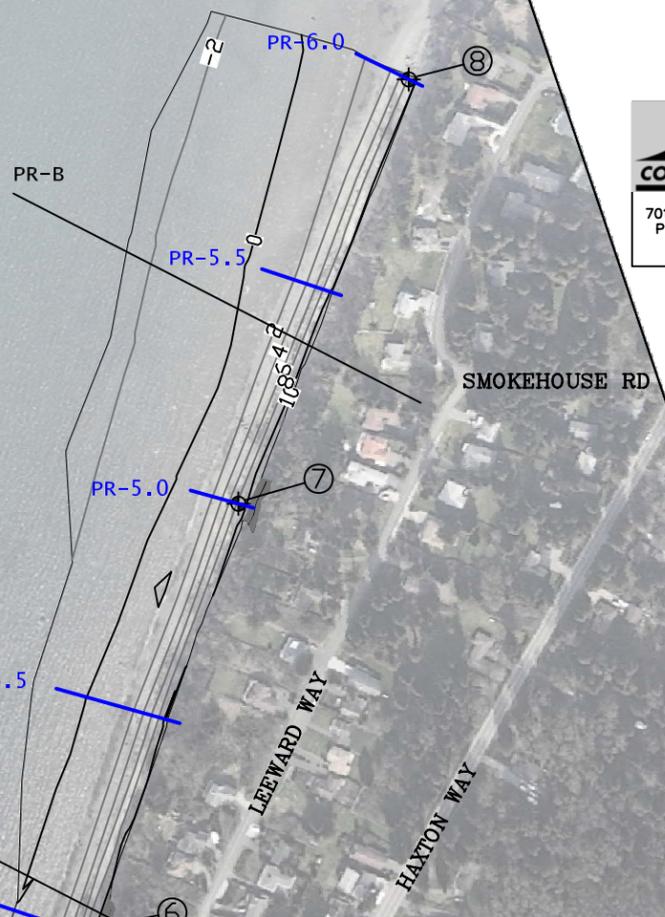
Sheet 1. July 2009 topography

Topographic and profile data were used to create a current topographic surface of the beach along West Beach. This surface was used to create a 2 ft contour interval map at 1"=400'. Note that the surface is not as accurate between profiles as this was a profile-based sampling effort. Profiles were drawn at 1"=25' horizontal, with a 2X vertical exaggeration. Aerial photography from Pictometry International Corp. dated March 11, 2004 was included for reference only.

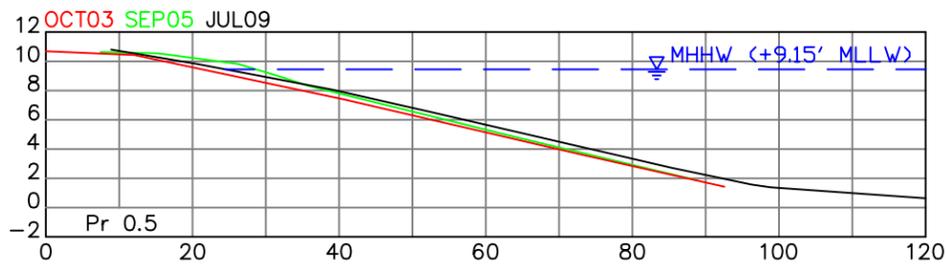
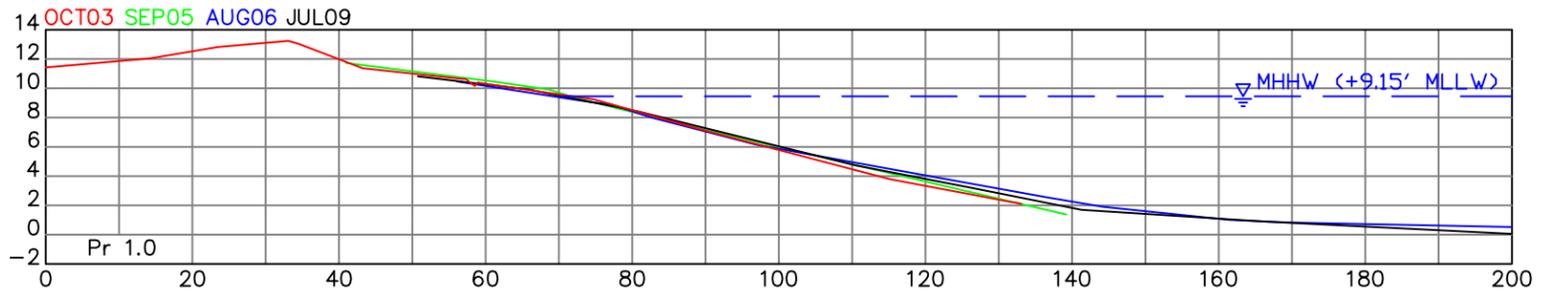
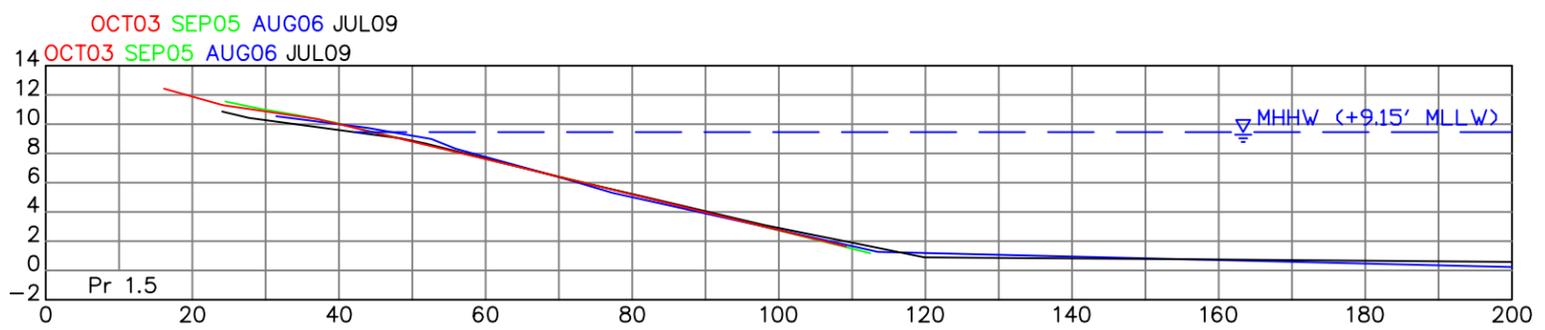
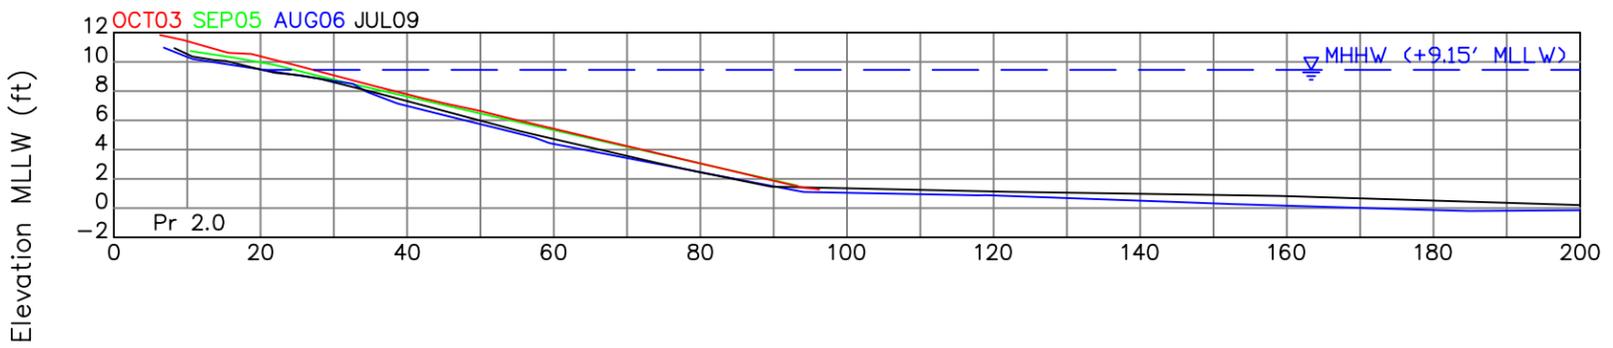
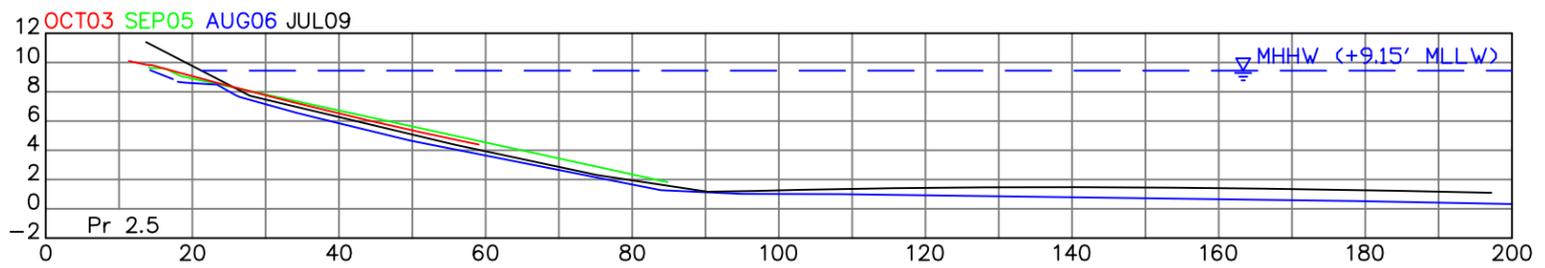
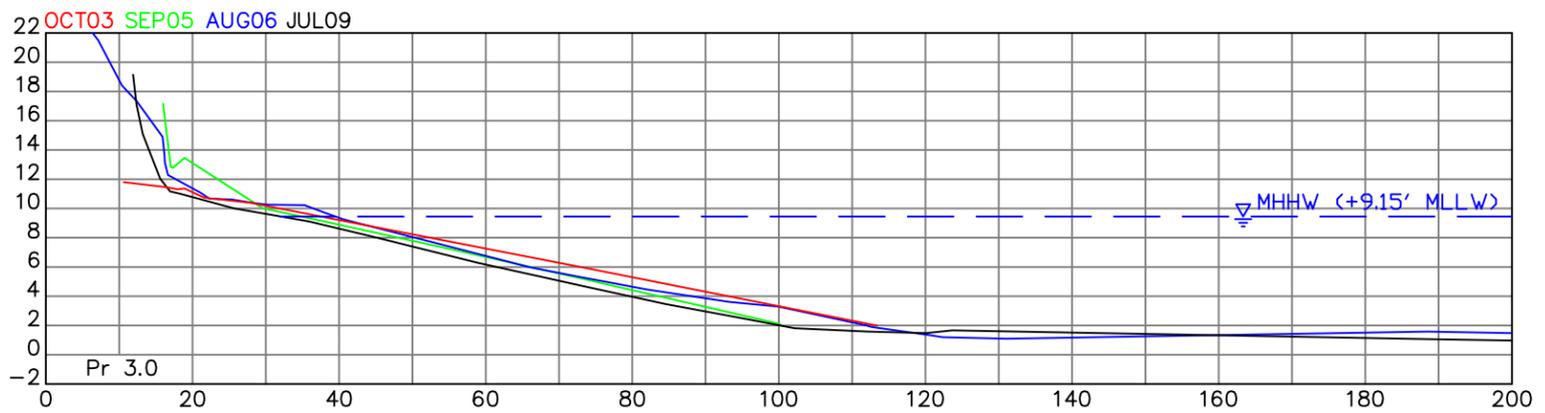
Sheet 2. Cross Sections for Profiles 0.5 to 3.5

Surveying had fallen approximately 10 ft short of Profile 0.5 in 2006, but the beachface had experienced minor erosion above mean higher high water (MHHW) relative to Cherry Point (NOAA station 9449424, at +9.15 ft MLLW), and minor accretion below MHHW since 2005 (Sheet 2). The beachface above +5 ft MLLW at Profile 1.0 has remained stable to slightly accretional since 2006, while below that very minor erosion was seen. The opposite condition was seen in Profile 1.5 where above +7 ft MLLW the beachface lowered slightly, and very minor accretion was seen lower on the beachface. The toe of the high-tide beach at Profile 1.5 had shifted waterward by 7 ft, although it was slightly lower in elevation than in 2006. Profile 2.0 was generally slightly higher in elevation than seen in 2006 except near MHHW where a storm berm was in 2006. The beachface at Profile 2.5 accreted substantially since 2006, being generally 0.5 ft above the 2006 elevation, and as much as 1.8 ft higher directly in front of the concrete bulkhead. The beachface at Profile 3.0 eroded substantially with up to 1.3 ft vertical lowering near the toe of the high-tide beach. The bluff face, which started between Profile 2.5 and 3.0, has continued to recede with up to 2.5 ft of horizontal erosion since 2006. Profile 3.5 was eroded somewhat both very low and very high on the beachface, while remaining relatively stable between +3 and +8 ft MLLW.

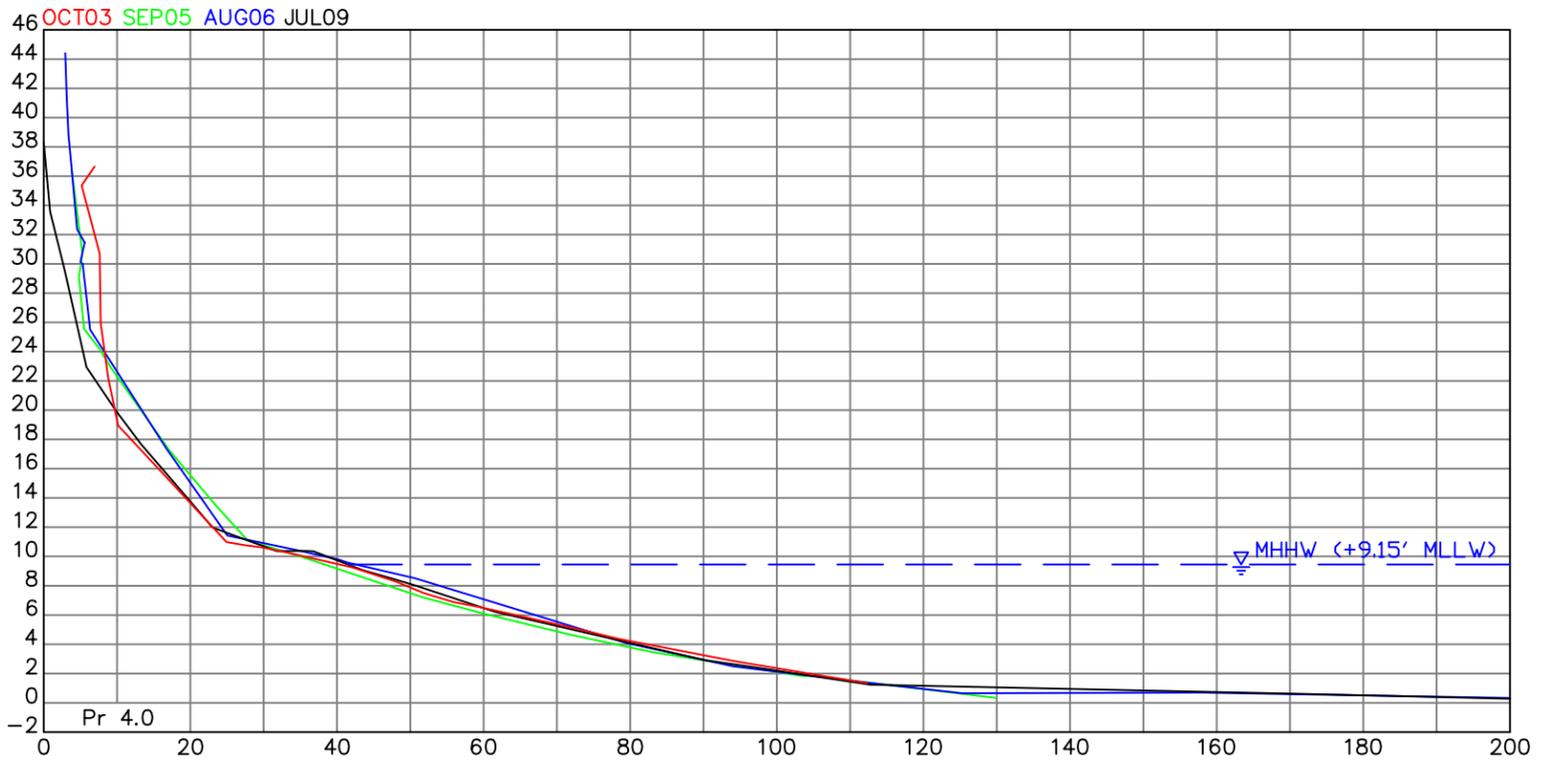
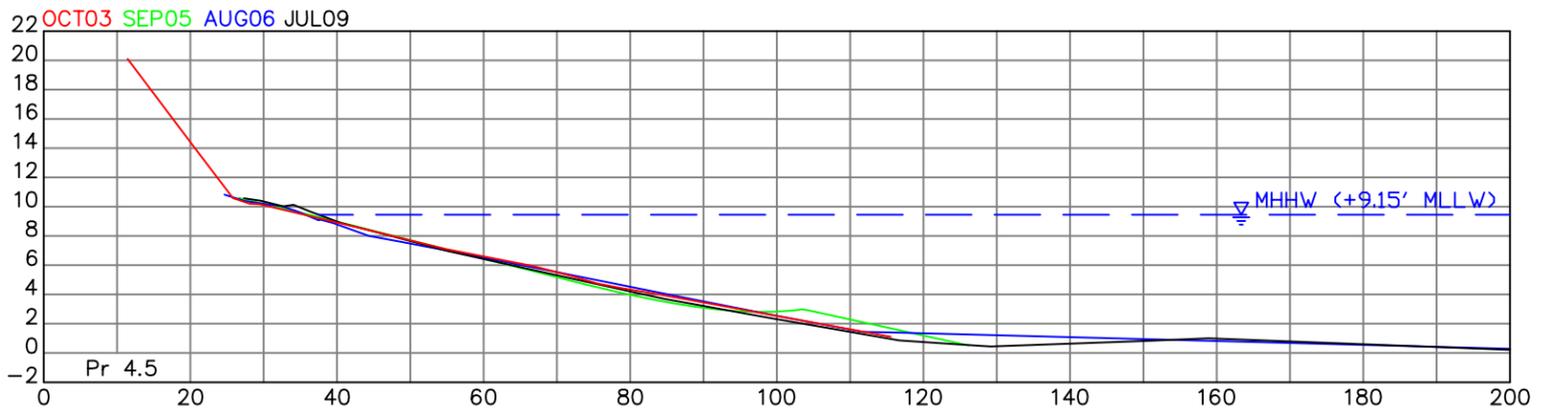
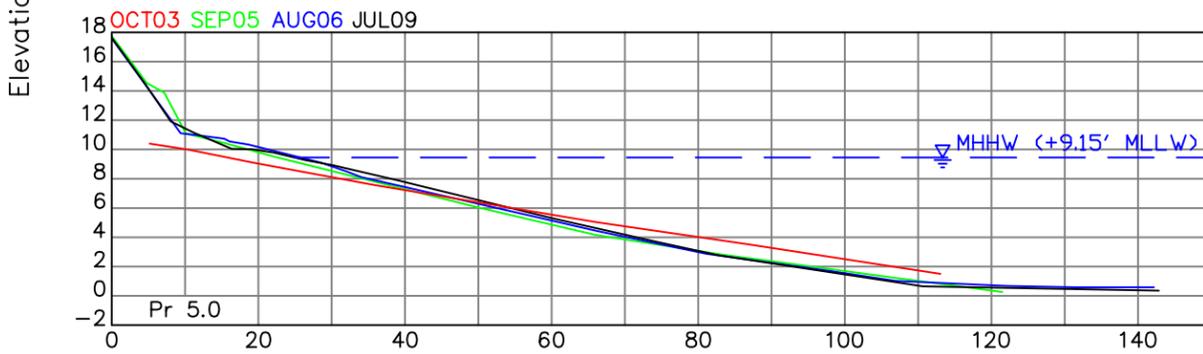
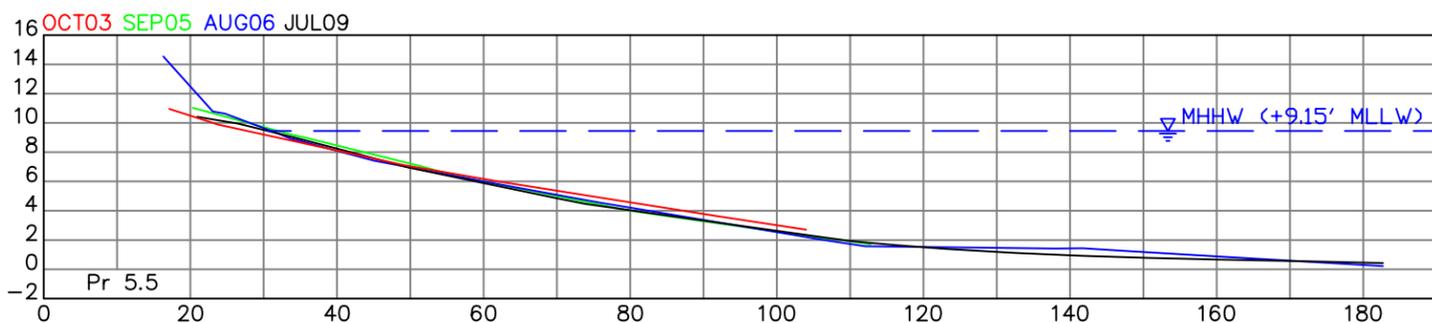
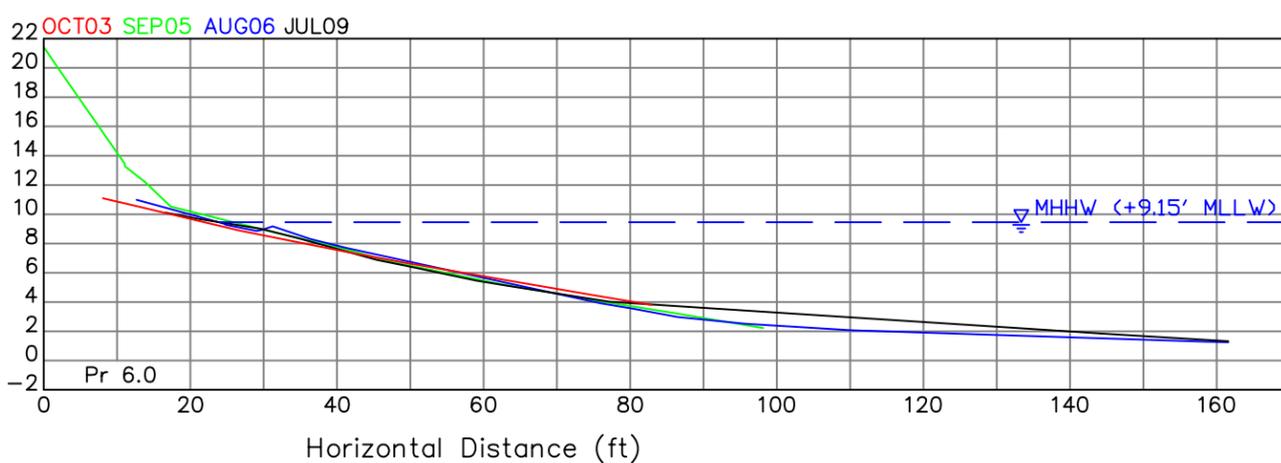
Sheet 3. Cross Sections for Profiles 4.0 to 6.0

Profile 4.0 contained the first section of high bluff surveyed directly (Sheet 3). The bluff face has steadily eroded by up to 5.2 ft horizontal since 2003, with the toe receding 2.0 ft (0.33 ft/yr). The beachface was stable to erosional with up to 0.6 ft of vertical lowering in the middle beachface since 2006. A minor storm berm at approximately +10 ft MLLW was seen in 2009. Profile 4.5 was slightly accretional above +7 ft MLLW where a storm berm was seen in 2009, and slightly erosional lower on the beachface. Profile 5.0 has remained relatively stable since 2006 with only minor accretion just below MHHW. The bluff face there has also remained quite stable, although the face of the colluvium has steepened somewhat since 2006. The beachface at Profile 5.5 has remained quite stable, although some erosion of colluvium occurred at the toe of the bluff. The northern-most end of the study area, Profile 6.0, was stable to slightly erosional.

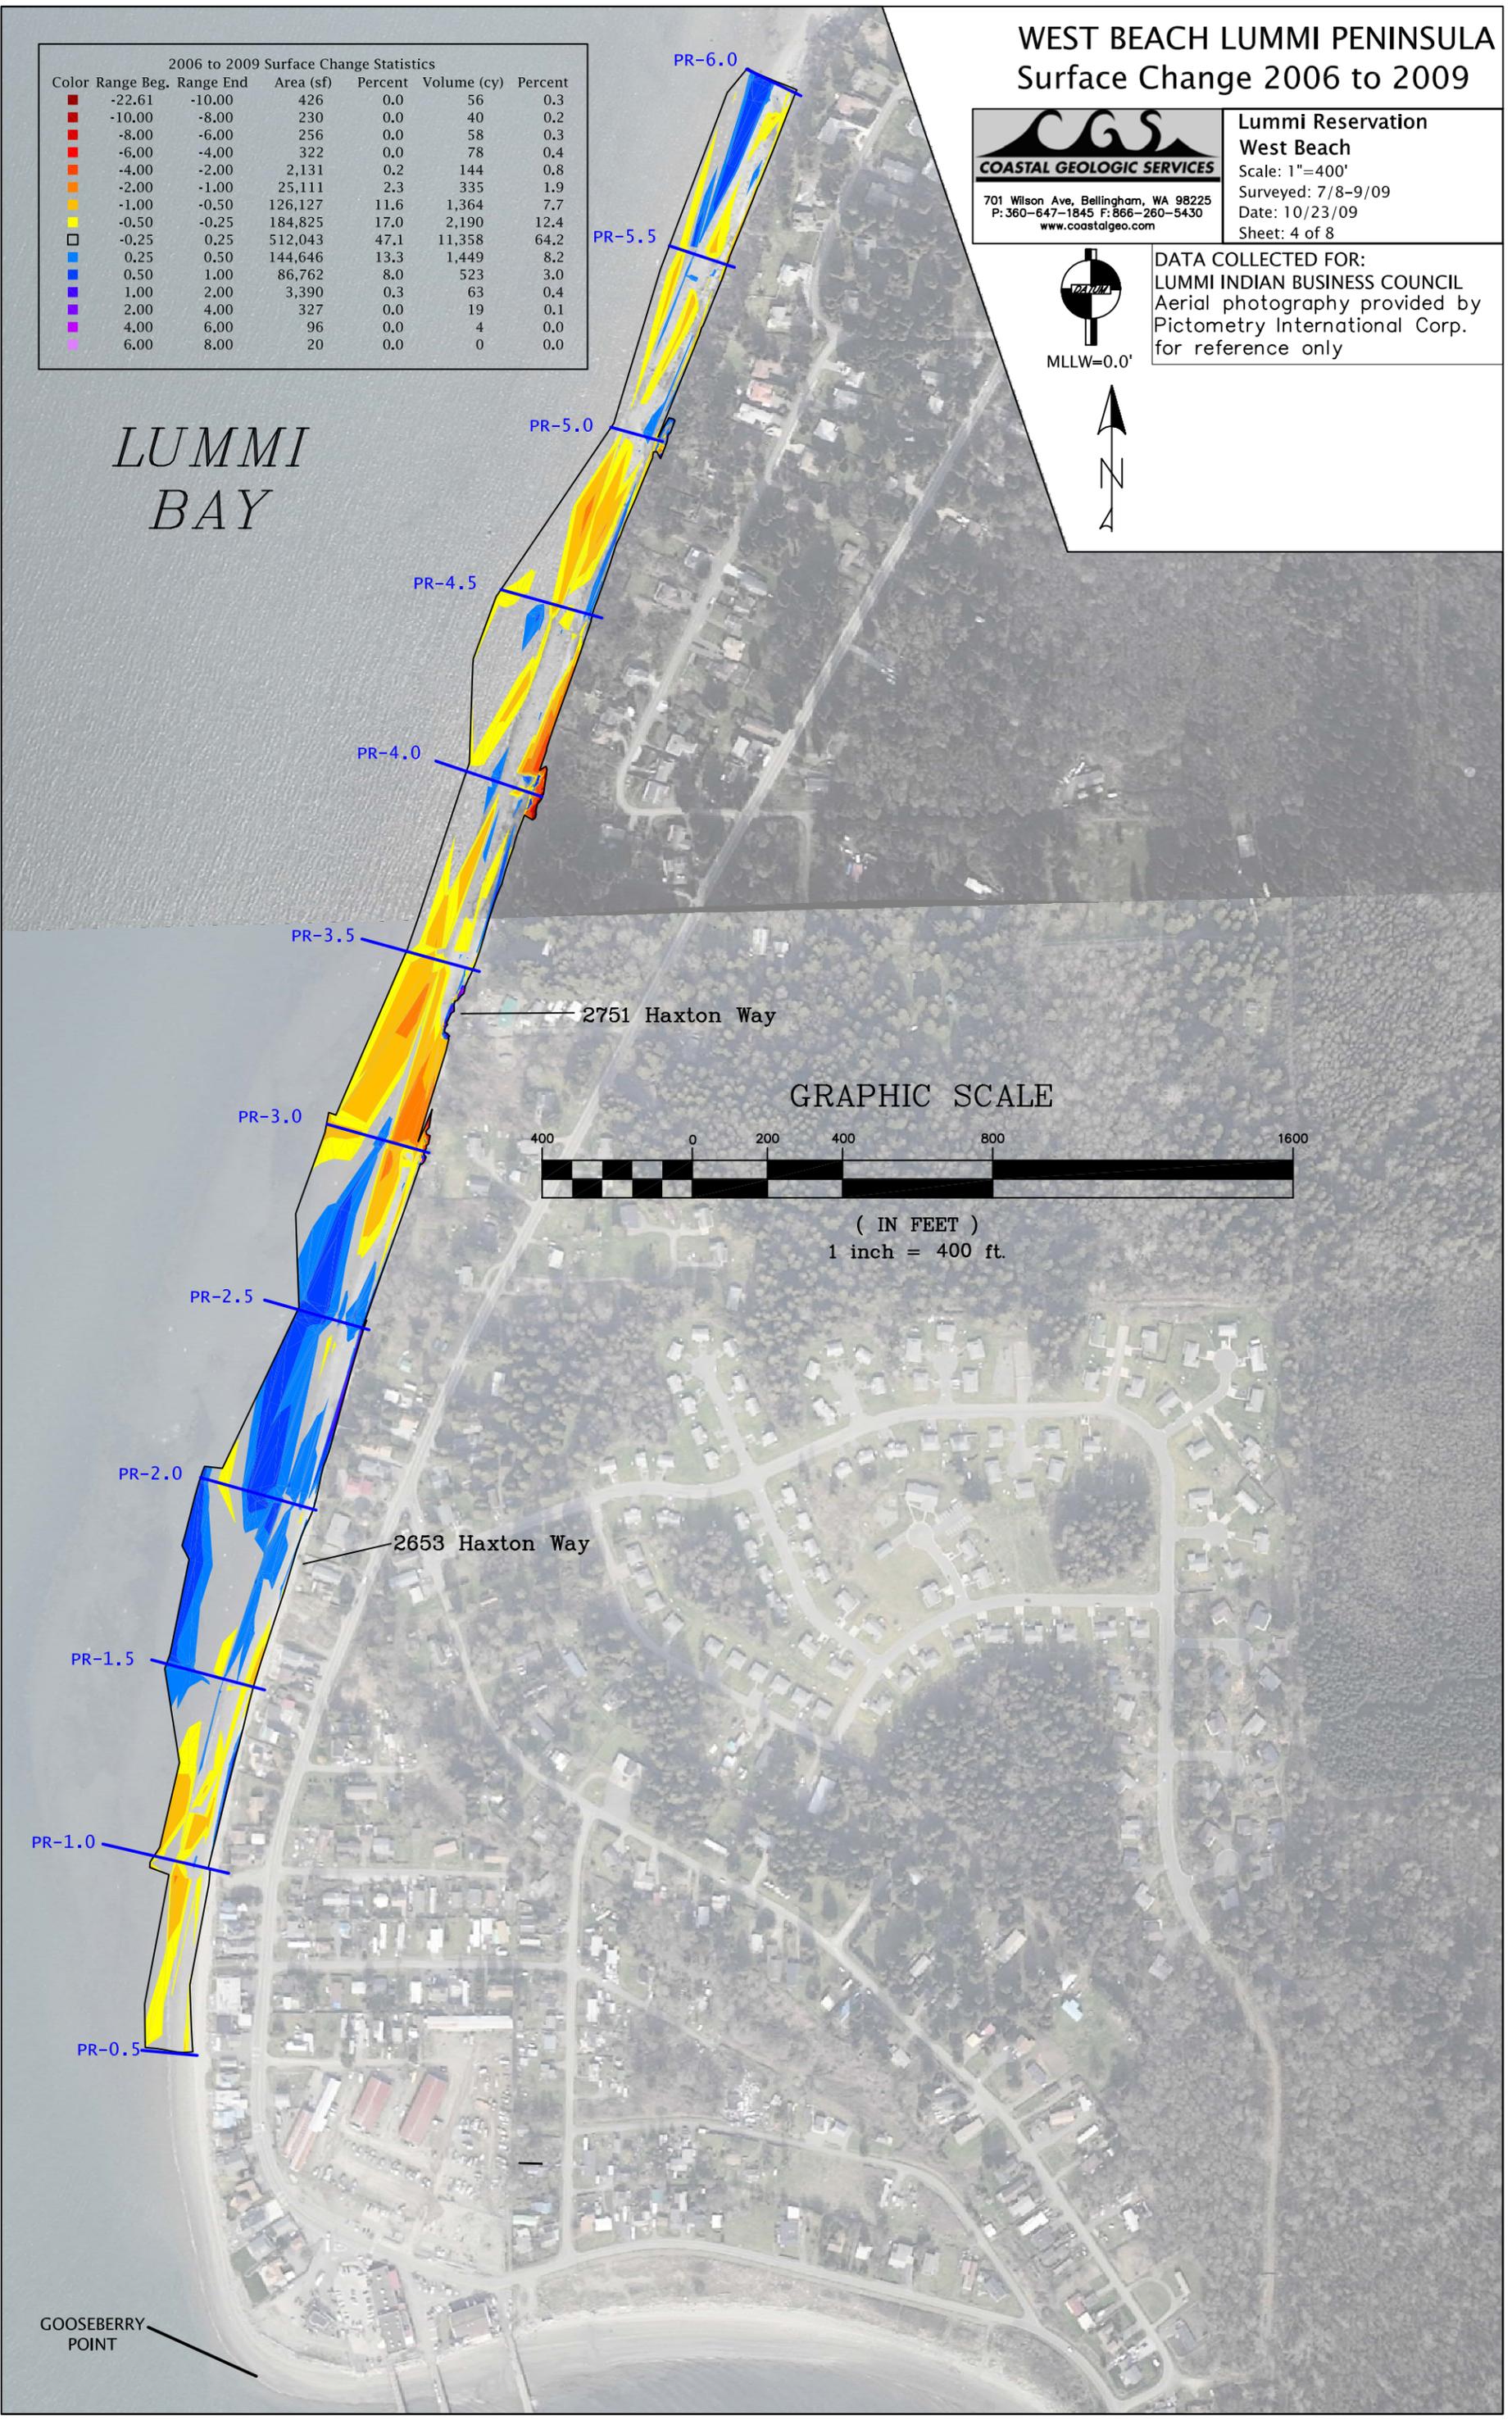
Sheet 4. Surface Change 2006 to 2009

The beach surface change analysis for the 2006 to 2009 period, which included beach topography at approximately 250 ft intervals between Profiles during these two years, showed variable pockets of erosion and accretion throughout the surveyed area (Sheet 4). Between Profiles 0.5 and 1.5 the beach was generally slightly lower than seen in 2006. A larger pocket of accretion, particularly within the low-tide terrace, is evident between Profiles 1.5 and 3.0. Immediately north of Profile 3.0 a pocket of erosion

resulted in as much as 2 ft of vertical lowering of the beachface. Erosion also occurred on the low-tide terrace in that area, but was 1 ft or less of vertical lowering. North of Profile 3.5 smaller pockets of erosion and accretion are evident, without the apparent trends seen in the southern end of the study area. Erosion appears to be the most evident change in the study area north of Profile 3.5 although there is an area of accretion between Profile 5.5 and Profile 6.0.

Almost half the study area remained relatively stable, with less than 0.25 ft vertical change between 2006 and 2009 (Sheet 4). Throughout the comparison area (including a broad section of low-tide terrace) approximately 8,700 cubic yards (cy) of sediment eroded and approximately 5,200 cy accreted. Therefore, a total of 3,500 cy of sediment was transported out of the study area. A separate examination of the surface change on the high-tide beach only shows 4,560 cy of erosion and 1,740 cy of accretion on the high-tide beach for a net loss of 2,280 cy. Most of the high-tide beach erosion occurred in small increments (less than 1 ft of lowering) across a broad area. One large pocket of upper beach erosion occurred between Profiles 3.0 and 3.5 and a second large pocket of upper beach erosion occurred between Profile 4.0 and Profile 4.5. A large area of high-tide beach accretion was evident between Profiles 1.5 and 3.0. Much of the material was likely transported during the relatively strong winter of 2006-2007, as much of colluvium was heavily colonized by vegetation during the July 2009 survey. Many of the large windstorms between 2006 and 2009 coincided with low- or mid- tides, which apparently caused lesser bluff erosion than seen in previous years.

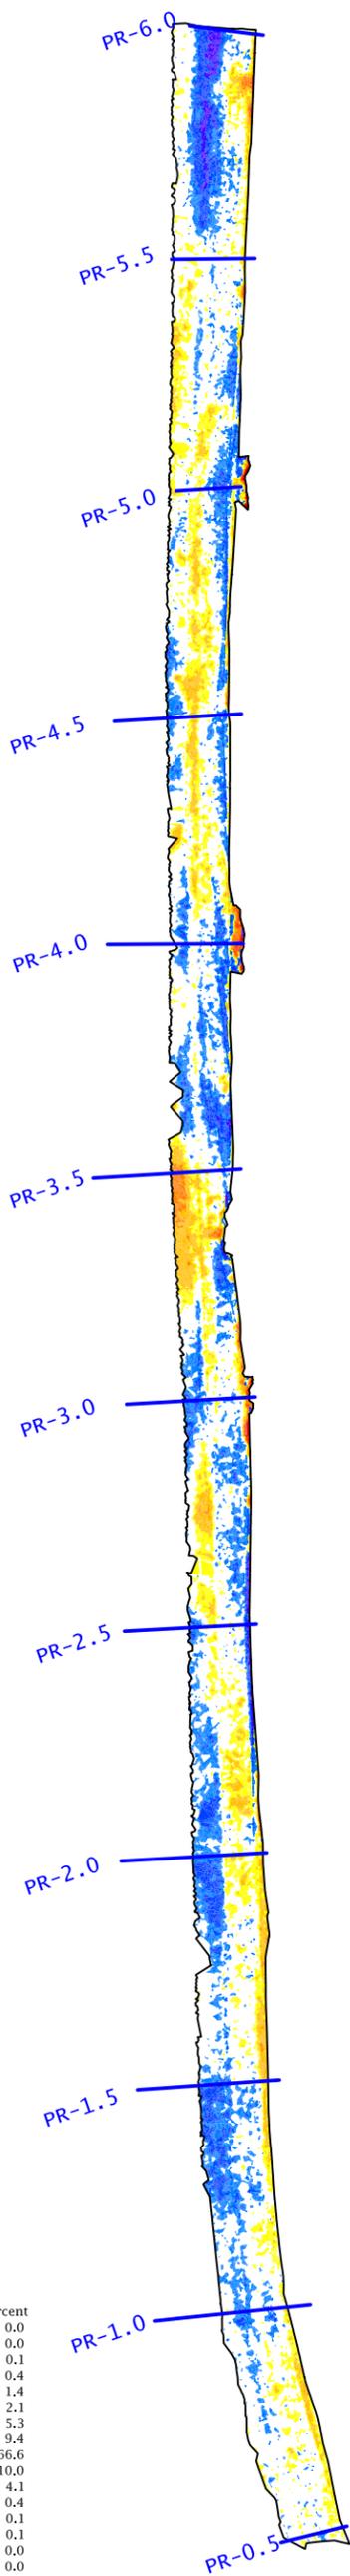
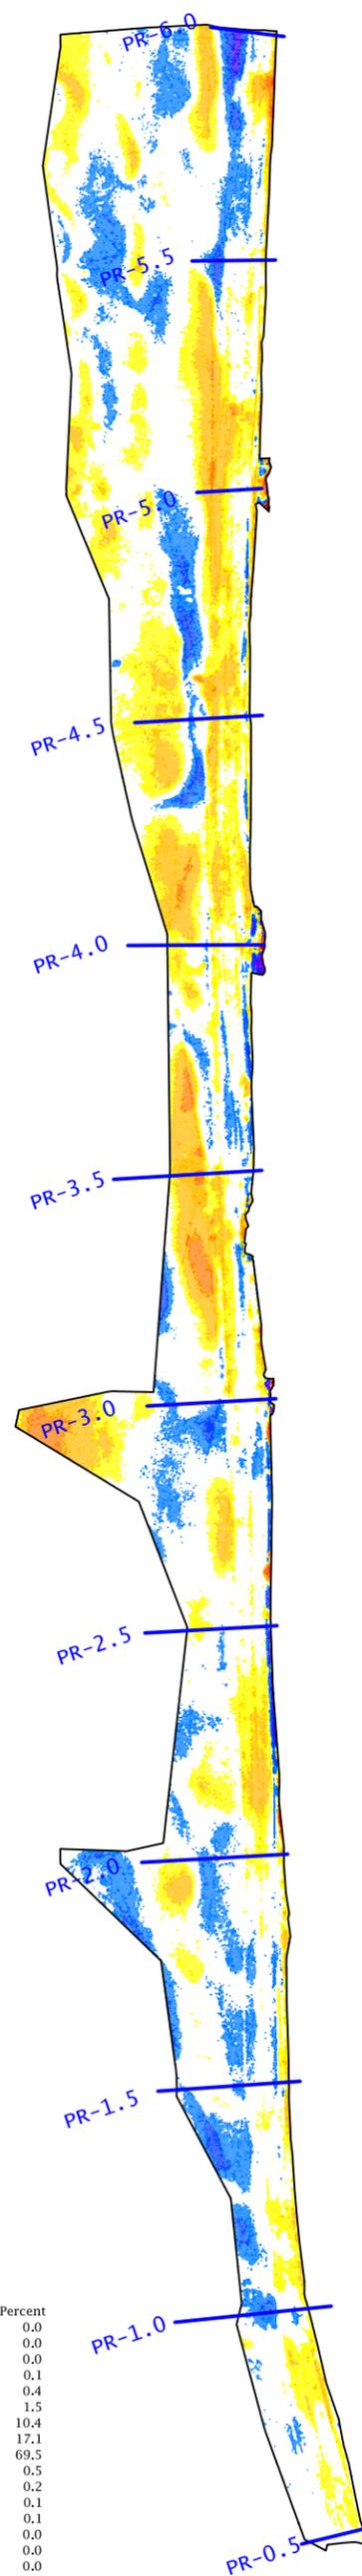
Sheet 6. Surface Change LiDAR to 2009

The majority (55%) of the adjusted 2005 LiDAR to 2009 survey comparison showed less than 0.25 ft of vertical change throughout the study area (Sheet 6). The comparison area showed 4,450 cy of erosion and 4,320 cy of accretion for a total loss of 130 cy from the area. The 2008 LiDAR to 2009 survey data comparison showed the majority (70%) of the study area was within 0.25 ft of the 2009 survey. Approximately 4,050 cy of erosion and 1,285 cy of accretion was computed for a total loss of 2,763 cy between 2008 and 2009. Therefore the LiDAR data suggested that there was accretion between 2005 and 2008, primarily on the upper beach since the 2005 LiDAR data coverage did not extend low on the beach.

These data should be considered with caution for purposes other than landscape scale analysis due to the nature of the LiDAR data. Bare-earth LiDAR data sets such as the ones used in this study undergo pre-processing to remove vegetation, buildings, and erroneous points. After removing all but the last return from each pulse there are still many returns that came back from above the ground. To get to a bare-earth surface the anomalies must be removed. To remove these spikes the LiDAR is sent through an automated process that looks at areas of very steep, sudden slopes in areas that are relatively flat and smooths those areas out by removing those points from the final dataset. The processing tends to also smooth sharp changes in elevation such as those found at the toe and crest of bluffs within the study area.

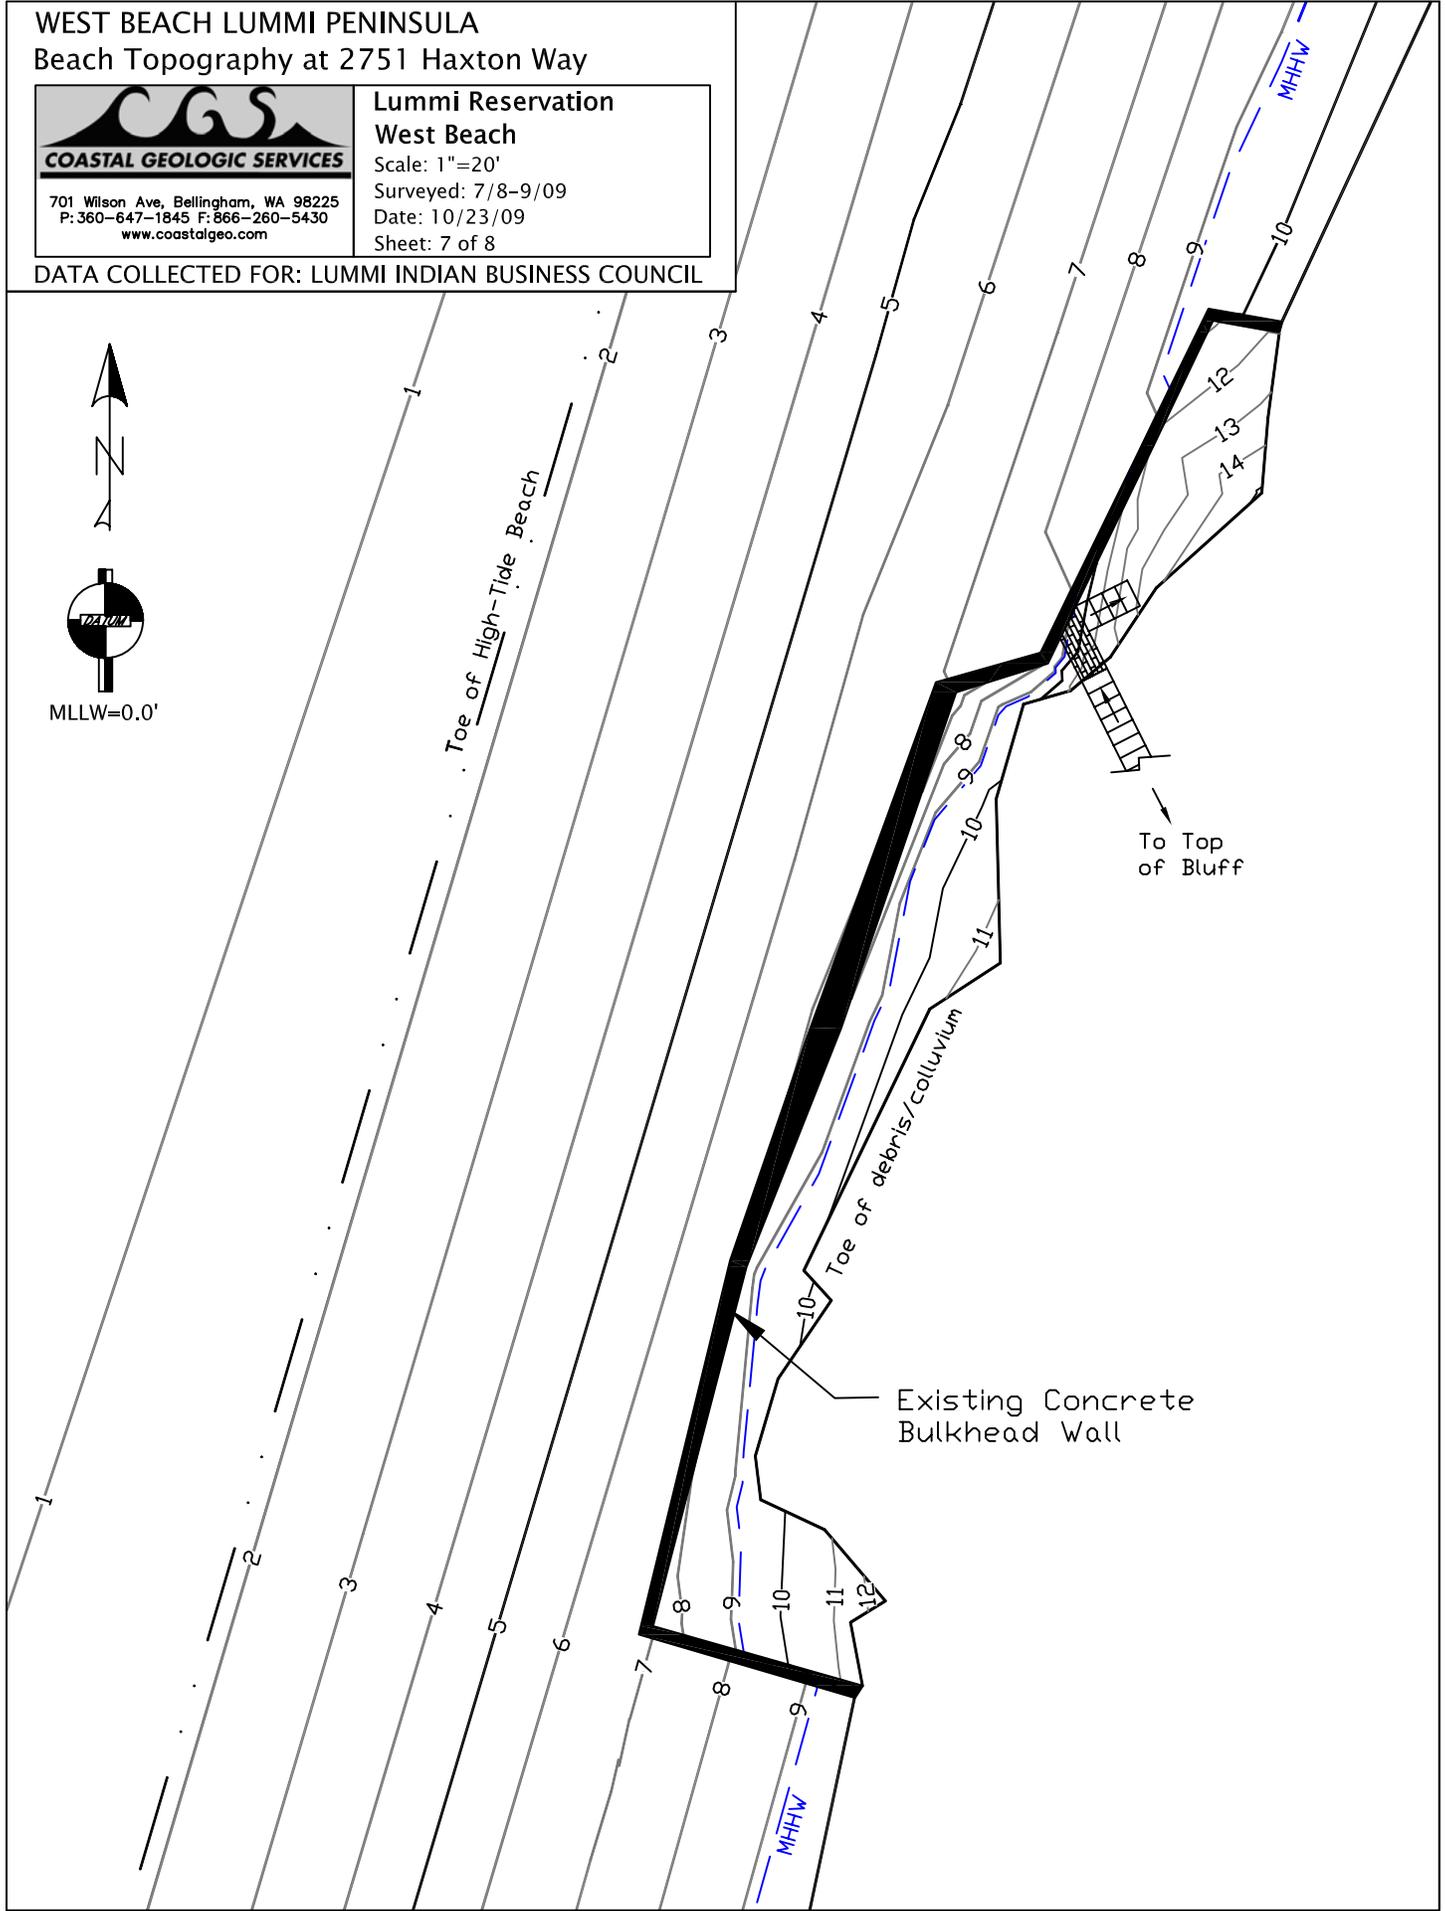
Sheet 7. Beach Topography at 2751 Haxton Way

A separate discussion of the property at 2751 Haxton Way is included here to inform management practices at this property. Previous data collection included measurements of the beachface waterward of the bulkhead, but did not include the area behind the bulkhead. The 2009 survey effort was the first year that included detailed topographic mapping landward of the concrete bulkhead fronting 2751 Haxton Way (Sheet 7). The bulkhead stretched a total length alongshore of 150 ft. The northern 40 ft was set 9 ft back closer to the bluff relative to the remainder of the bulkhead. The waterward portion of the bulkhead was located at +6.8 to +7.0 ft MLLW, well out on the active beachface. Cracks in the concrete wall face separated the bulkhead into three large pieces, although they were still held together by the structural rebar (Photo Page 5). The cracks have allowed waves to reach behind the bulkhead, and appear to provide a means for sediment to be transported out to the greater beach system, albeit at an apparently slow rate. The concrete sections have been hard-hit by waves, and were tilted landward at various angles, but the wall sections had not fallen to the beach. The northern section appeared much more stable, and remained in its original vertical condition. The fill material and bluff soils that were likely present behind the wall were largely eroded by the time of the 2003 surveying. The 2001 oblique aerial photograph showed the rock had been placed landward of the bulkhead, which appeared cracked already (Photo Pages 5 and 6). Between 2001 and 2009., some amount fill was lost landward of the concrete bulkheads, and several additional landslides occurred. Bluff soil was more exposed by 2006 (oblique photo), as a number of bank face trees were lost along the majority of the area landward of the concrete bulkhead.

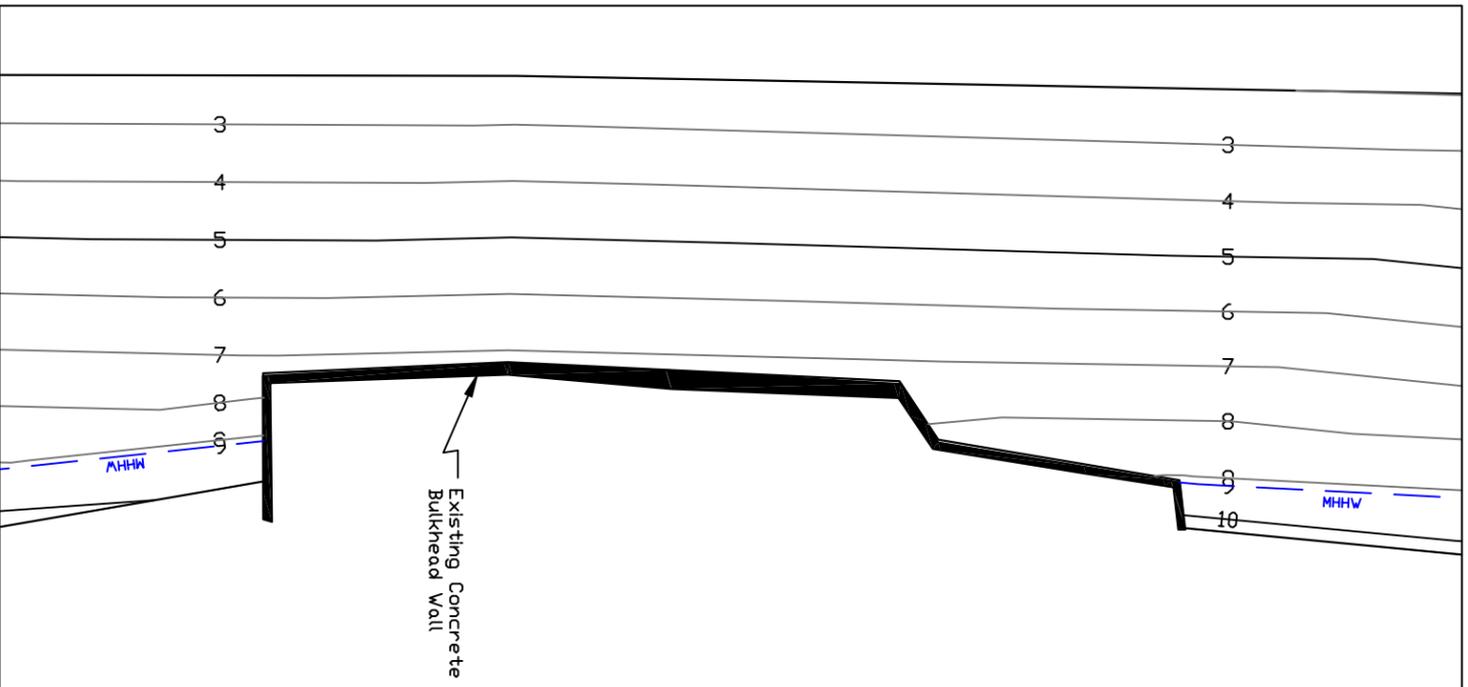
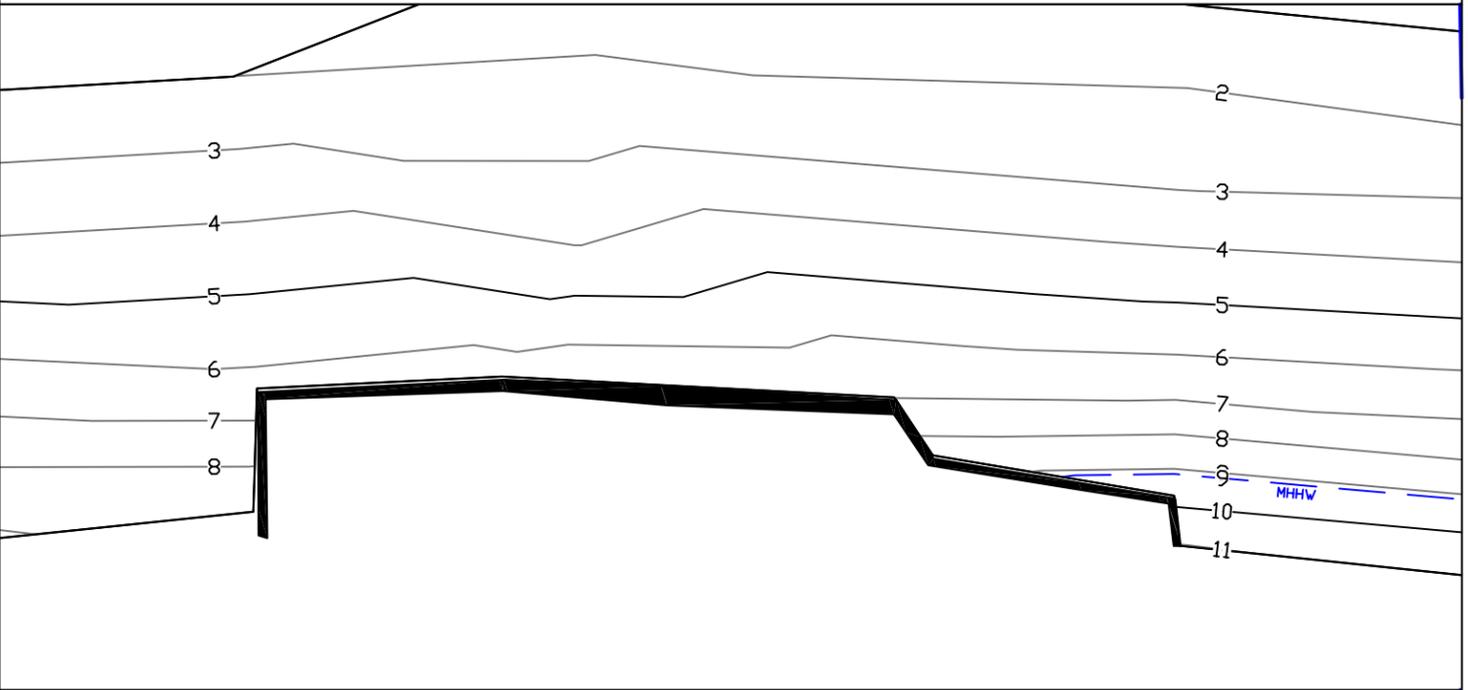
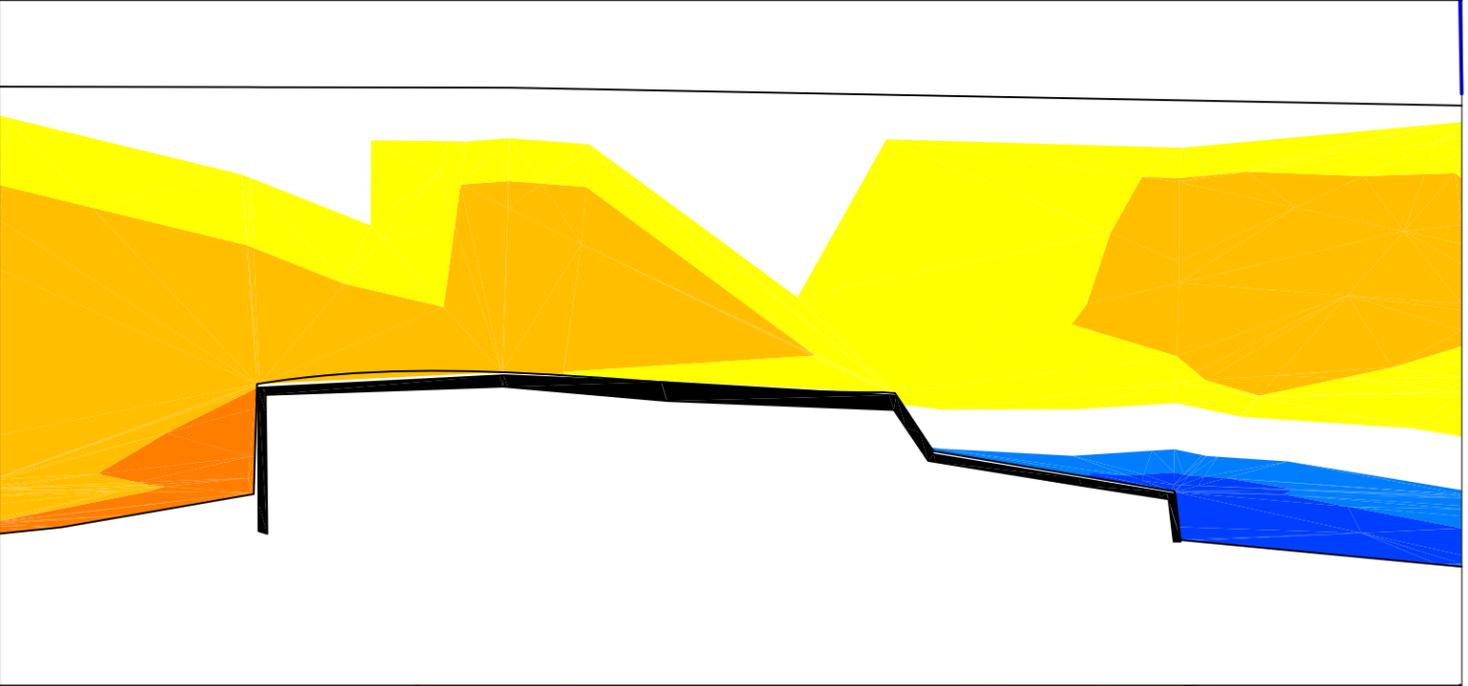
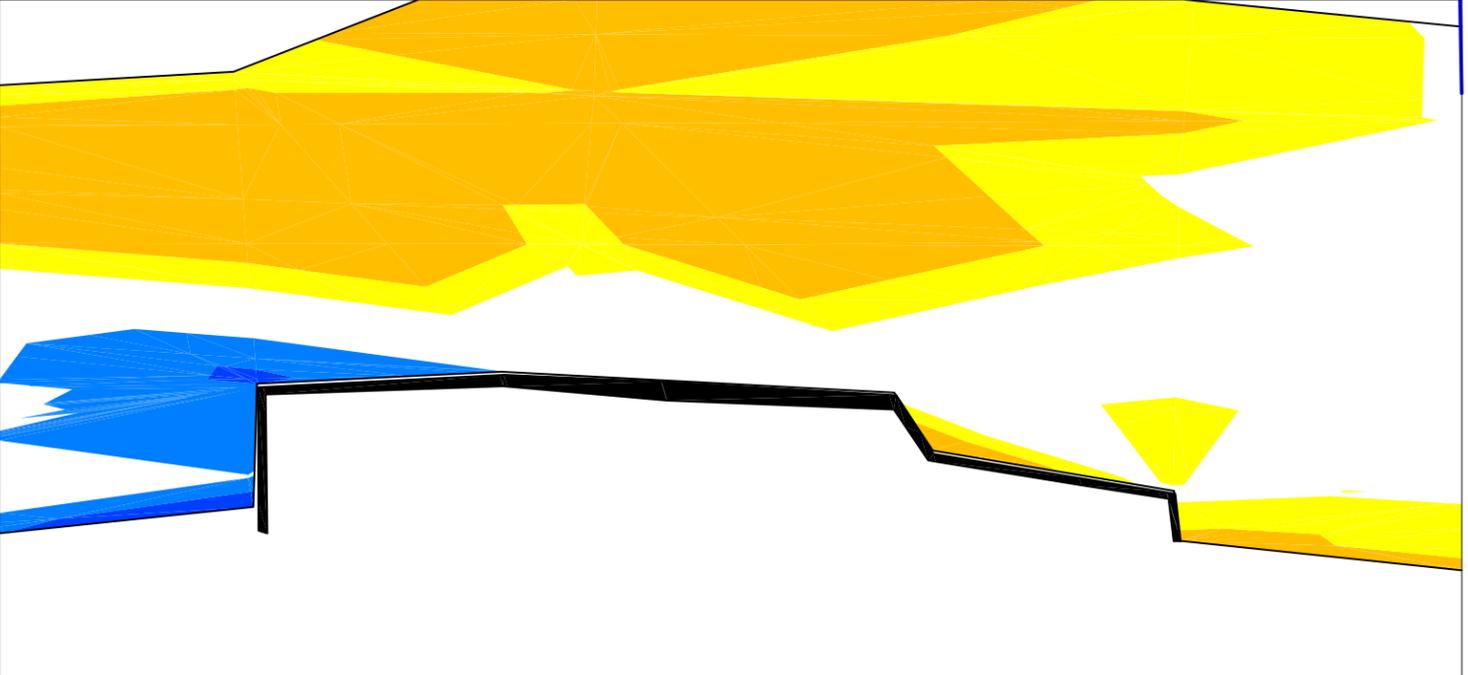
Sheet 8. Surface Change at 2751 Haxton Way

The beach waterward of the bulkhead at the 2751 Haxton Way property experienced erosion between 2003 and 2005 and also in a smaller area, between 2005 and 2009 (Sheet 8). Erosion was less than 1 ft (vertical) in both periods, but the beach did progressively lower in the area waterward of the bulkhead. The upper beach erosion was less in the upper-most beach close to the bluff toe. The bluff toe has receded approximately 7 ft adjacent to the south end of the bulkhead and approximately 2 ft adjacent to the north end of the bulkhead.

note: No data was collected behind the bulkhead prior to 2009, so comparison can only be made waterward of the wall.
