**date:** October 20, 2009  
**to:** Jeremy Freimund, Lummi Nation Water Resources Manager  
**fr:** Jim Johannessen LEG, MS, and Jonathan Waggoner, CGS  
**re:** **Lummi Reservation – Final West Beach Summer 2009 Beach Monitoring**

# WEST BEACH LUMMI PENINSULA Beach Topography, July. 2009

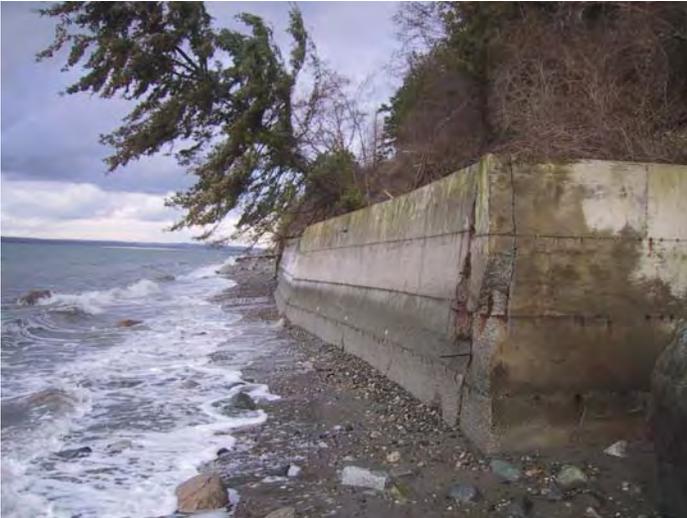
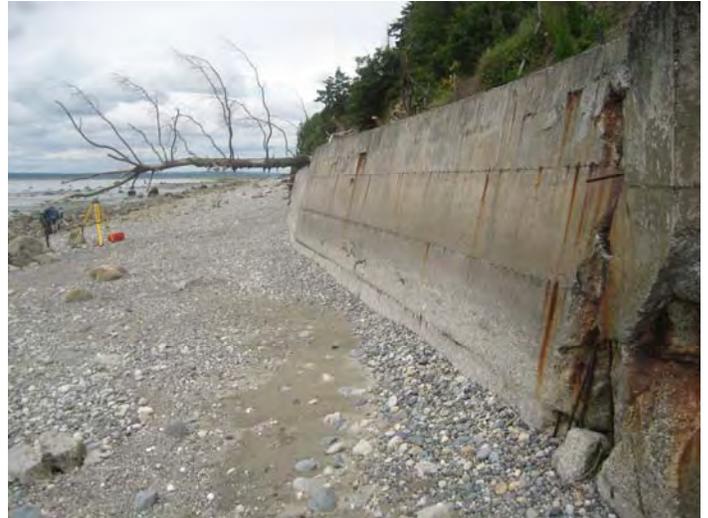
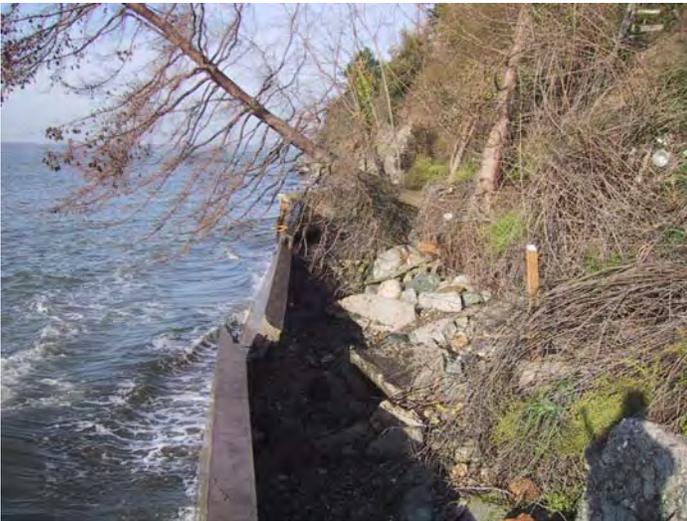
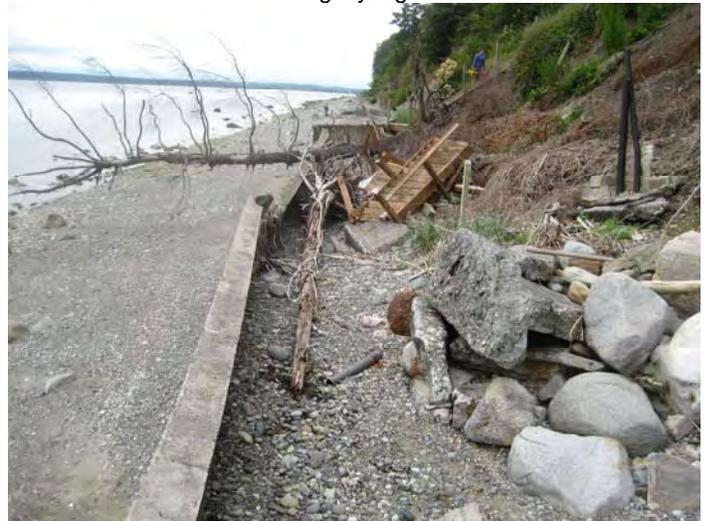
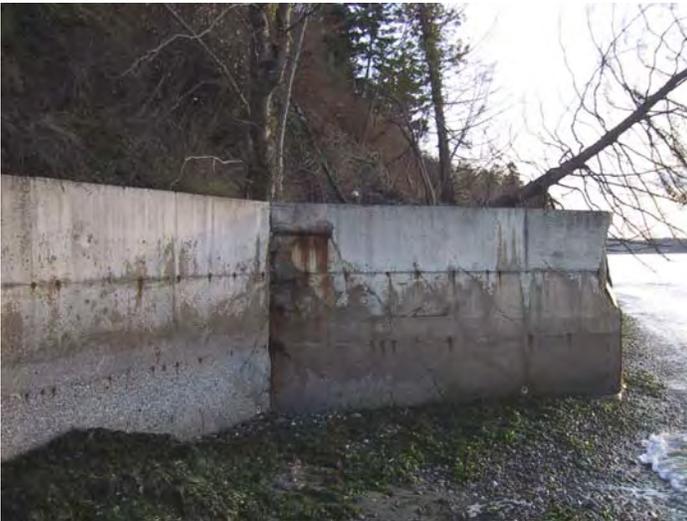
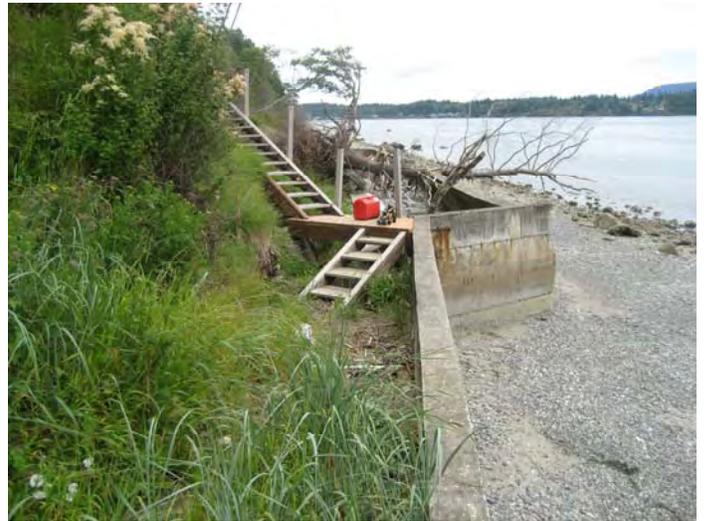
**Photo Page 5.** Views of the concrete bulkhead at 2751 Haxton Way, photo dates shown

A large amount of debris remained behind the southern section of bulkhead in 2009 (Photo Page 5). The debris consisted of pieces of broken concrete, rock, old sections of bluff staircase, sections of pipe, and various pieces of flotsam and jetsam that had been thrown behind the wall by wave action. One large tree, which had apparently fallen just prior to a January 2001 field visit, remained leaning out over the central portion of the bulkhead. Several similar bulkheads were observed north of 2751 Haxton Way, and all have failed completely, remaining as concrete slabs on the beach. The recent high input of bluff sediment from slides to the beach will likely be lost to continued littoral drift in the coming years, unless the high rate of landsliding continues. This may add the impacts of ongoing wave attack reaching the concrete bulkhead, which has numerous cracks. This may contribute to wall sections becoming further degraded.

The bluff face behind the bulkhead at 2751 Haxton Way was failing and receding despite the presence of the bulkhead during the period of study, indicating that the bulkhead no longer provides the level of protection it was designed for. Under existing conditions, it appears that the staircase is not located in a stable location, and may be lost due to wave attack during a severe windstorm or through bluff failure following a heavy rainfall.

7/8/09 – note that beach is slightly higher

Given the condition of the southern 110 ft of the bulkhead, it is unlikely that it will continue to provide even the degraded level of bluff protection that it currently provides over the medium or long term. Failure of the bulkhead appears to be unavoidable unless it is completely reconstructed. We recommend the following actions be considered for the site:

1. Ensure that the upland drainage is controlled in the developed portion of the property to greatly reduce overland flow at the bluff crest so surface water does not de-stabilize the existing bluff.
2. Plant fibrous-rooted native vegetation along a 20-30 ft wide band of the uplands at the bluff crest
3. Attempt limited planting of the bluff face using appropriate fibrous-rooted native vegetation in areas of relatively low slope (a concentrated effort is not recommended as revegetation success may be quite limited on the bluff face due to ongoing instability).
4. When and if the existing beach access stairway is damaged, remove the existing 110 ft southern section of the bulkhead.
5. Soft shore protection does not seem appropriate in this moderately high wave energy setting, as soft shore would not be robust enough to provide shore protection for any length of time.

6. Retain the northern 40 ft section of the bulkhead if it is needed to protect the toe of a repaired/replaced beach access stairway. A new section of return wall would be required at the south end of the wall sections left in place to protect the new stairway, which should extend into the bluff toe some distance.
7. Portions of the stairway will probably need to be relocated (northward) to avoid the unstable area above the southern and middle sections of the concrete bulkhead.
8. A stair tower would provide a more stable beach access system that would very likely significantly outlast a rebuilt conventional stairway for this location (and be considerably more expensive).
9. Federal and tribal permits will be required for this work.

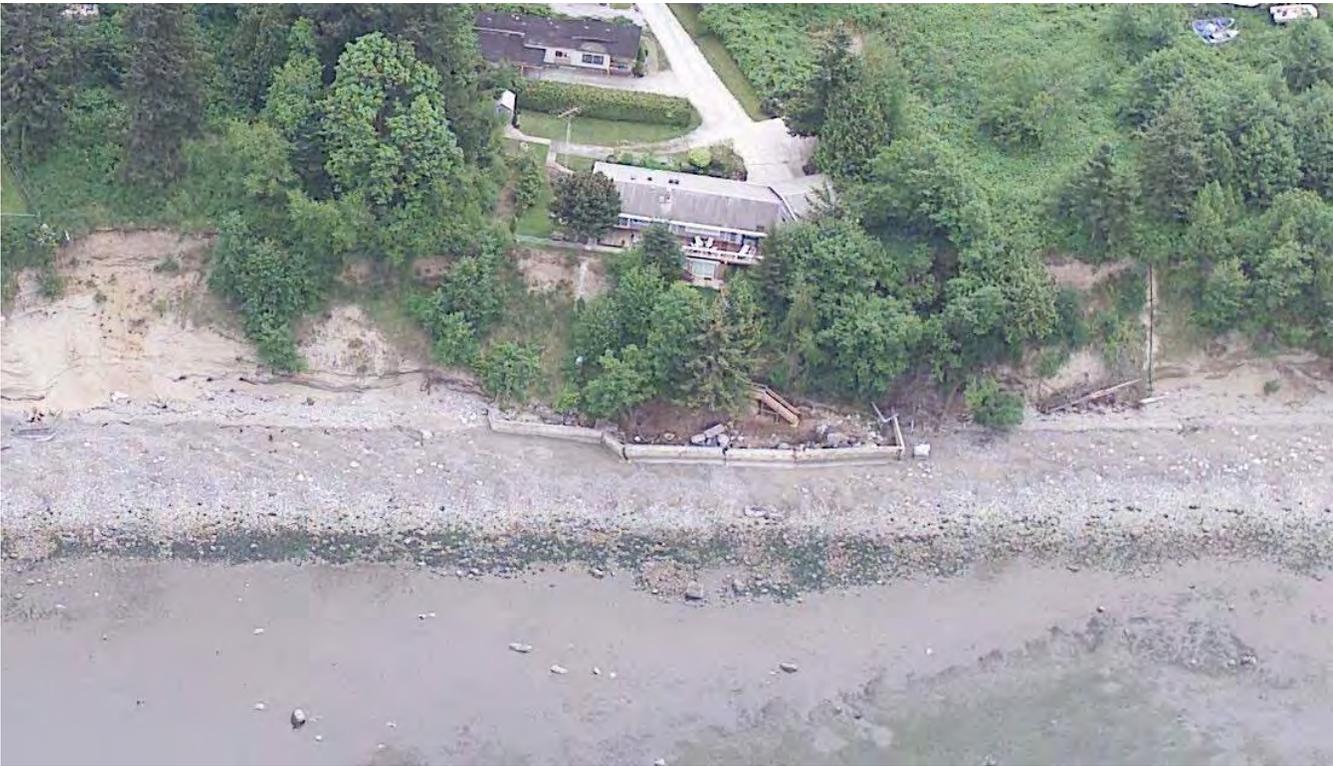
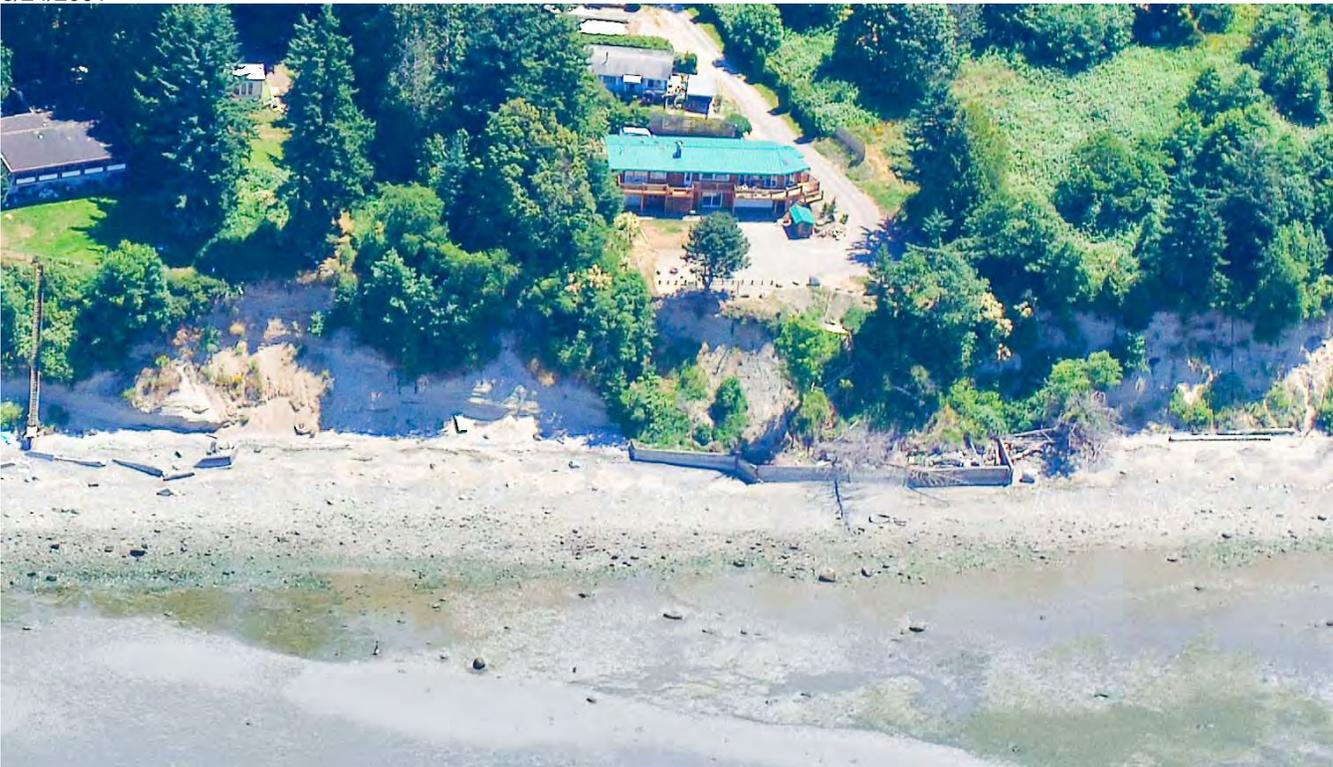
**Photo Page 6.** Oblique aerial photographs of the shoreline fronting 2571 Haxton Way from 2001 and 2006. Photos courtesy WA Dept of Ecology.

The mobile home that was located adjacent to the bluff crest was removed after the 2000-2001 bluff failures. Now the waterward portion of the uplands is used as a parking lot (Photo Page 6). The examination of upland features was not part of the current effort, but the lack of a vegetated bluff crest buffer to both reduce surface water runoff and increase the soil-binding qualities of fibrous-rooted trees and shrubs does not aid in slope stability. Drainage may also be an area for improvement at this site. Additional bluff crest recession is very likely at this site as beach erosion has occurred, the bluff remains oversteepened, vegetation management is not as good as it could be, and wave attack does reach the bluff toe, although at a reduced level as compared to shore reaches with no form of a bulkhead. The bulkhead is also causing increased wave refraction at the un-bulkheaded areas adjacent to both ends. This has likely contributed to additional erosion adjacent to the bulkhead, particularly the north end.
